ROTARY INTERNATIONAL AND USAID'S WASH PARTNERSHIP IN GHANA – SUSTAINABILITY ASSESSMENT

FINAL REPORT

APRIL 2021

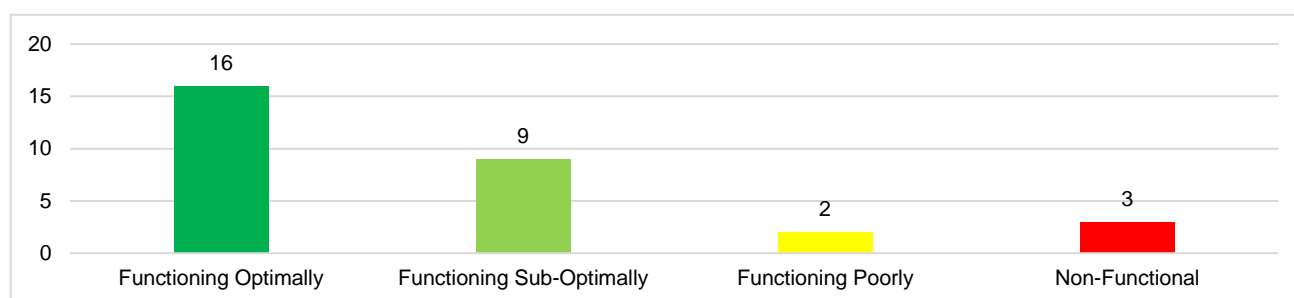
Figure Two: Community Water Supply – Functionality

The functionality of the 30 community water supply facilities (29 hand pumps and one mechanised borehole) was determined by whether the facility provided water at the time of inspection as well as by conducting stroke and leakage tests.^{13 14 15} Each assessed community water supply facility has a functionality score, based on the simple colour coded system presented below.

Function poorly: The hand pump provides water; however, it failed both the stroke and leakage tests

Functioning sub-optimally: The hand pump provides water but failed one of the stroke or leakage tests

Functioning optimally: The hand pump provides water and passed both the stroke and leakage tests

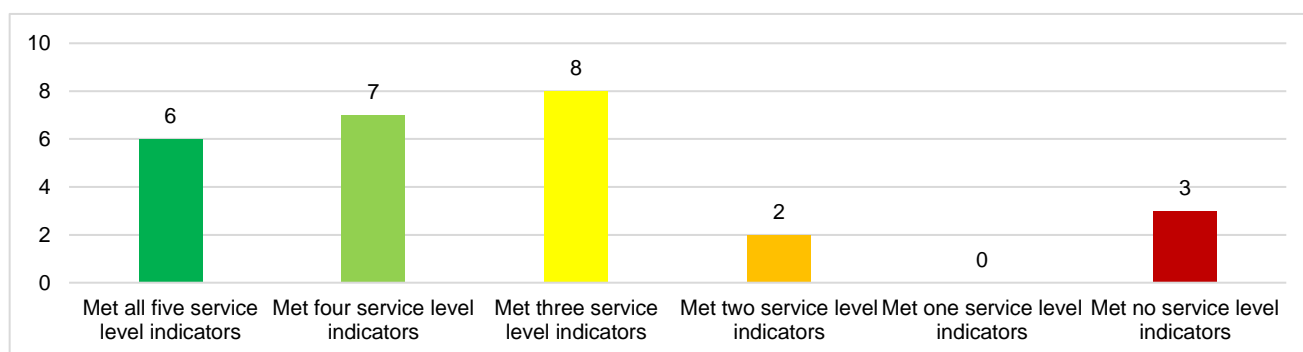
Figure Four: Community Water Supply – Service Levels

Figure Four provides an overview of the service level scores. Although most interventions do not meet all service level indicators, these results are still relatively positive. **Twenty-three percent of assessed RI-USAID WASH Partnership community water supply interventions (six of 26) provide a 'basic' service level.** For comparison, a large 2013 CWSA and IRC study using a comparable methodology and indicators found that only 13% of rural water facilities provided a 'basic' service level (IRC & CWSA, 2013). Quantity and reliability service level indicators scored comparatively positively, with 22 and 19 of the 26 assessed community water facilities meeting these criteria, respectively. Conversely, the water quality, crowding and accessibility indicators scored relatively poorly, with only 21 facilities meeting the water quality requirement and 13 facilities meeting each of the crowding and accessibility criteria.

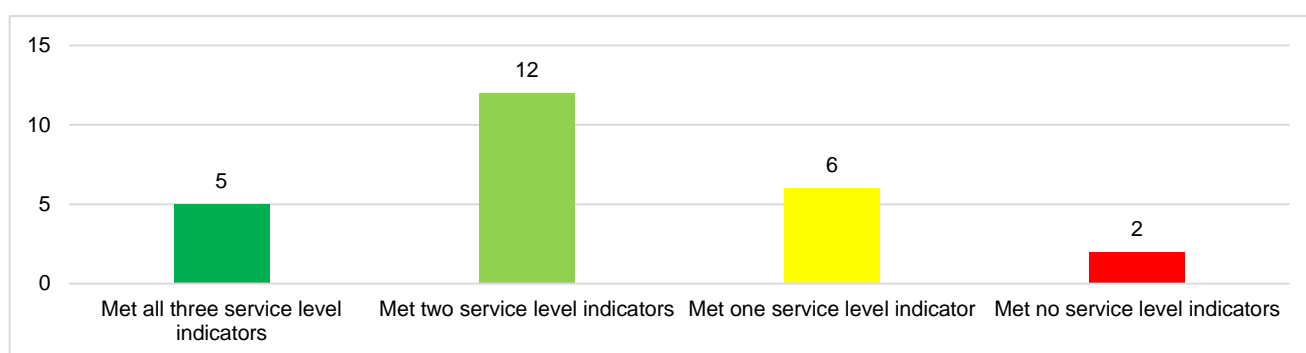
Figure Eight: School Latrine Blocks – Service Levels

The school latrine blocks' service levels were evaluated against three criteria:

1. Facility has a handwashing station with a dedicated cleaning agent (i.e., soap) available.
2. Facility complies with crowding standards (at least one pit per 50 school children).
3. Facility is in a sanitary condition with anal cleansing material available.¹⁹

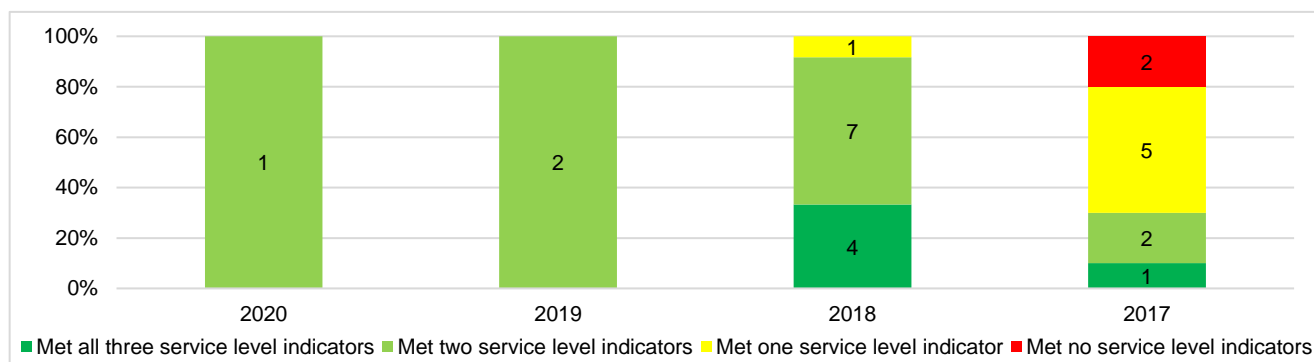
Figure Nine: School Latrine Blocks – Service Levels per Year of Construction

Figure Nine details the service level scores according to the year that the school latrine block was implemented. **It highlights deteriorating service levels according to the year of implementation, which raises concerns about the service levels provided by the school latrine blocks over time.**

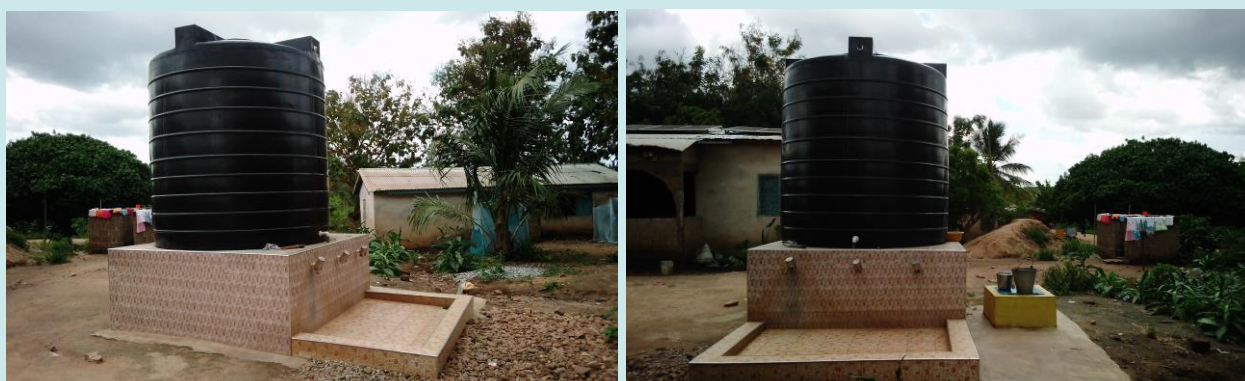
Box One: Fante Mayera WSMT illustrates good financial management:

The Fante Mayera (Ga South Municipality) WSMT was one of 12 WSMTs to implement a pay-as-you fetch tariff. This tariff is not based on CWSA guidelines and was instead determined according to what users were willing to pay. However, the tariff of GHC 0.2 per 18 litre jerry can is paid by a high percentage of households (reportedly 80-99%) and is higher than the average pay-as-you fetch tariff amongst assessed facilities of GHC 0.1 per 18 litre jerry can. This comparatively high-level of willingness to pay is linked to the fact that this was a mechanised borehole and has enabled the WSMT to accrue a revenue of GHC 1,500 (equivalent to US\$258). Repairs have not yet had to be performed on the facility; however, this accrued revenue provides an important safety-net for if these are required.

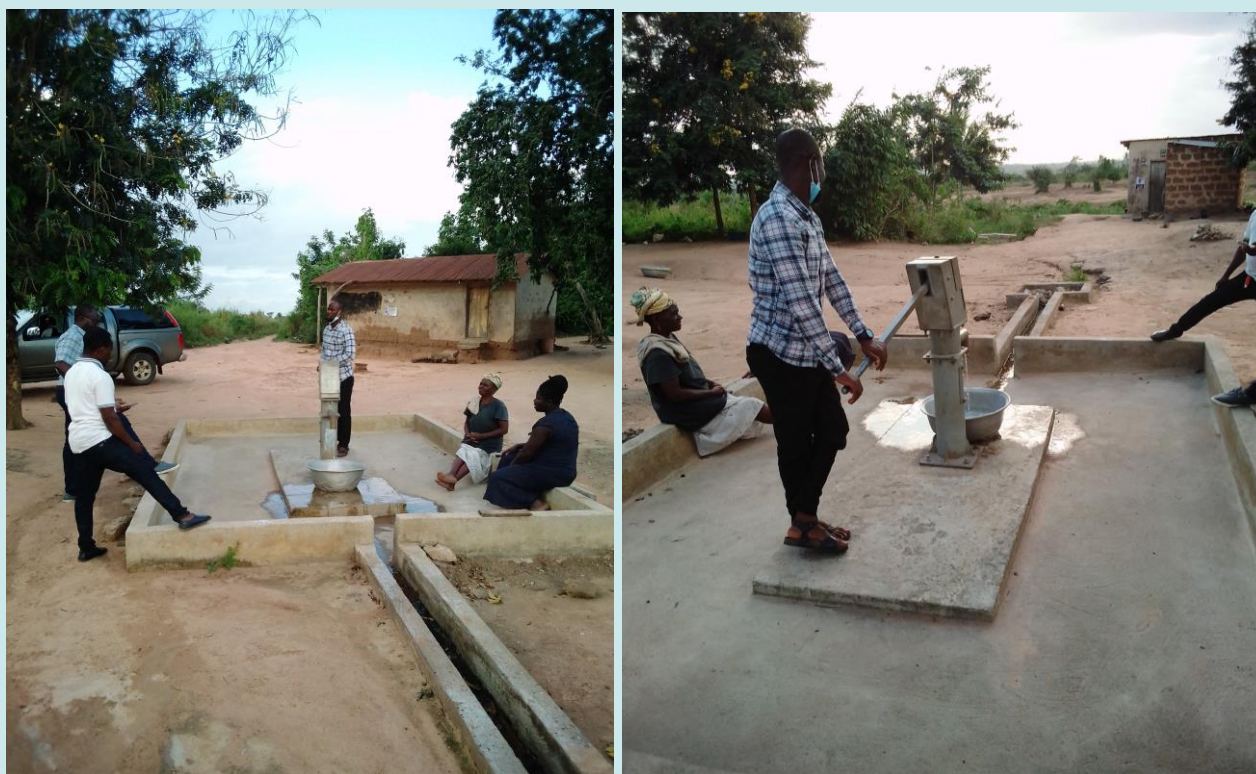
Box Two: Tebu (Agbi) illustrates some WSMTs' ability to organise repairs:

Tebu (Agbi) community water supply facility serves about 200 people, over a comparatively large area (less than 50% of users are located within 500 metres of the hand pump). The WSMT has the tools and skills to conduct preventive maintenance, which is performed quarterly. Nevertheless, the hand pump has broken down three times since its installation in December 2018 and was non-functional for 50 days in 2020. On each occasion, the WSMT has, with the Assembly's support, been able to access a local area mechanic to perform repairs. However, each time this has been a protracted process. The hand pump is currently functioning optimally – it passed the stroke and leakage test, and while the WSMT complained that the water was salty, it is not contaminated with *E. coli*.

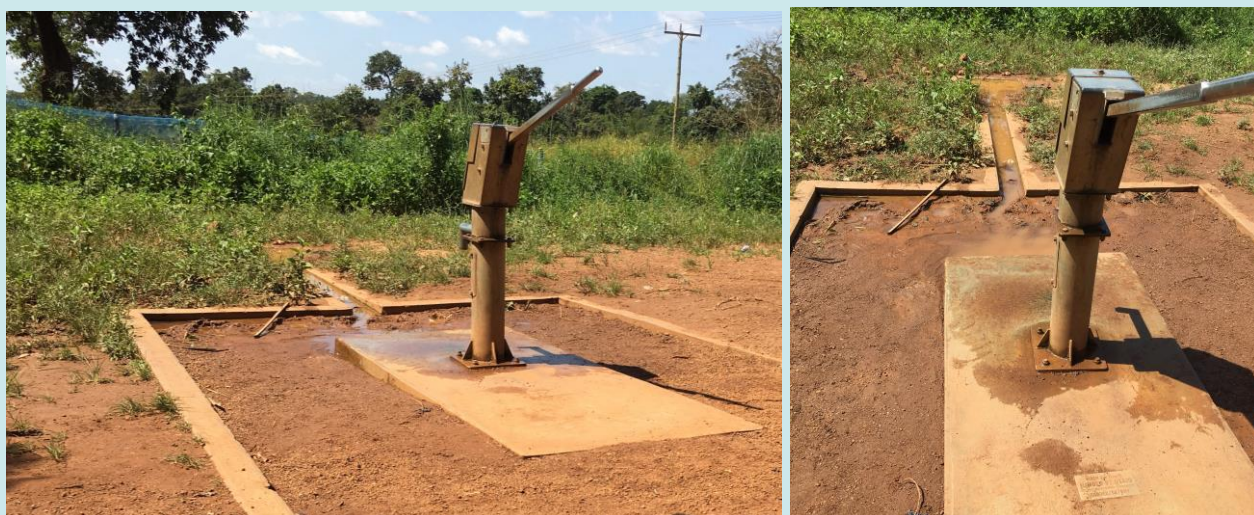
The Agou Junction community water supply (Nkwanta South District) is poorly cited. It is in a low-lying, marshy area, which can be expected to have a higher water table. This is a possible cause of the water from the pump's cloudy colour and salty taste. The site is lower than the road, so there is also a high chance of runoff water coming from the road and neighbouring plots. As the pictures below indicate, soils around the pump do not drain water properly and the facility has become covered in a large amount of soil. Additionally, the facility is around 500 metres from community, creating accessibility challenges for a large portion of the community. Significantly, the WSMT, community headman and community members note that their inputs were ignored when the facility was sited. There was reportedly no formal introduction to the contractor, and the WSMT reported that the contractor did not consult them before siting the facility at the outskirts of the community.

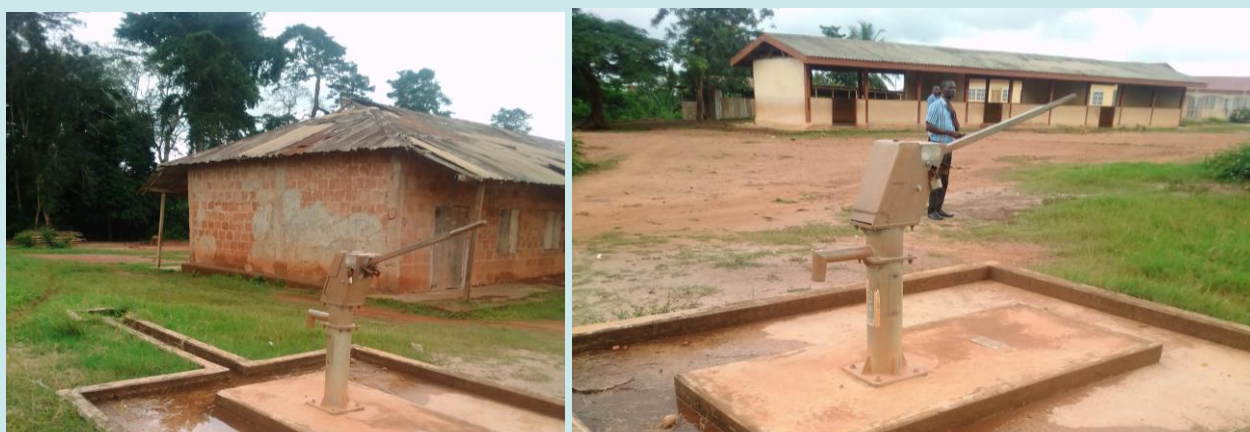
Box Four: Ampiah-Ajumako DA Methodist Basic School struggles to finance repairs:

The hand-pump constructed for the Ampiah-Ajumako DA Methodist Basic School (Ajumako Enyan Essiam District) broke down four times in the past year. The last breakdown occurred a few days before schools were closed in March 2020 because of COVID-19. In the first instance, Rotary/USAID/Global Communities provided assistance to have it repaired. Subsequently the school has engaged the services of local area mechanics to repair the facility. The last repair cost the school GHC400 (equivalent to US\$68.00), with the school only able to pay GHC200 and still owes the area mechanic GHC200. The head teacher reports that following the re-opening of the school, the school is unable to engage the services of the area mechanic to repair the non-functional facility due to financial constraints.

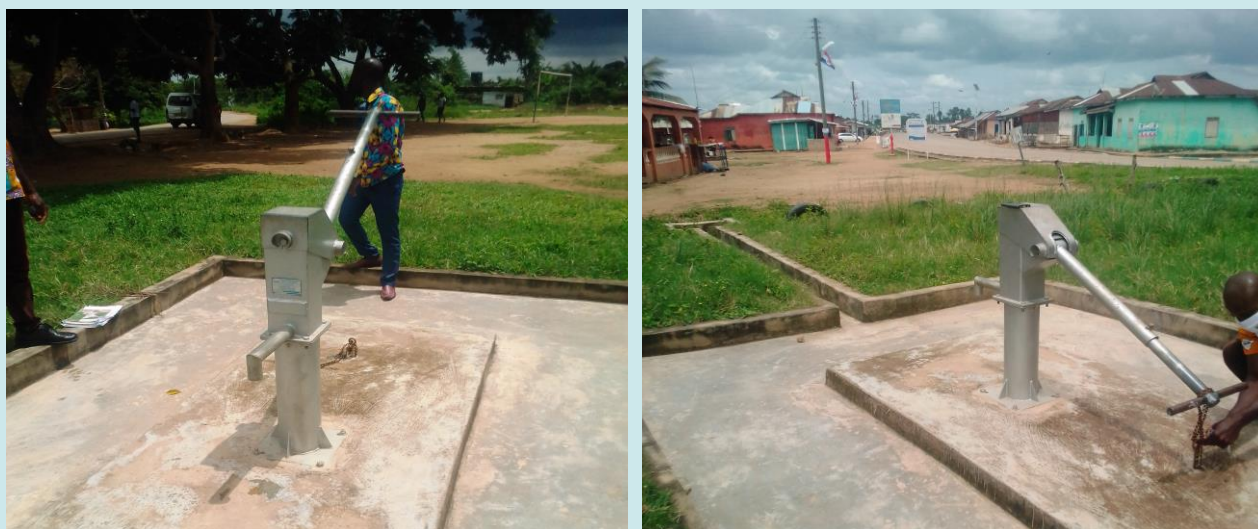
The School-Based Health Coordinator for Brofoyedru Basic School (Ajumako Enyan Essiam District Assembly) has the requisite skills and tools to perform preventative maintenance on the hand pump. He reportedly performs preventative maintenance on the facility every three months. Given the financial constraints that schools face, it is necessary to ensure that a member of staff is trained and equipped to perform regular preventive and minor repairs (see Sub-Section 7.4.3. for the recommendation on this).

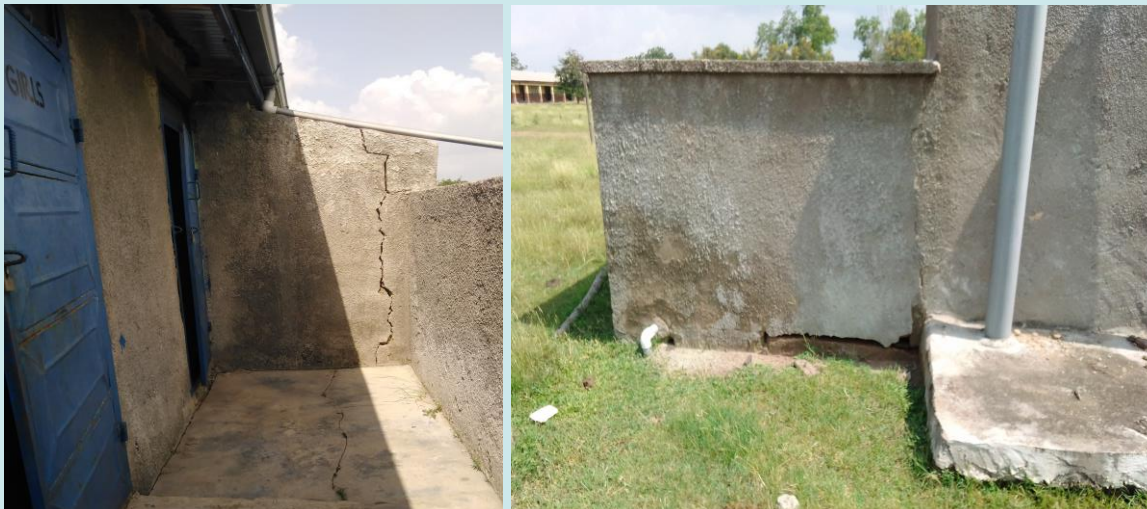
Box Eight: Cracked floors and walls and rusting metalwork

At the Kongo D/A Basic School in Shai Osudoku District, the toilet facility had developed deep cracks in the floors and the wall. In some parts of the structure, these cracks ran from the roof level to the ground. These cracks are likely to have developed due to the nature of the soils where the facilities have been sited. Some other structures on the school's compound had developed cracks (though not as severe as those observed on the toilet facility). A teacher remarked that the pupils are scared to use the facility because of the severity of the cracks.

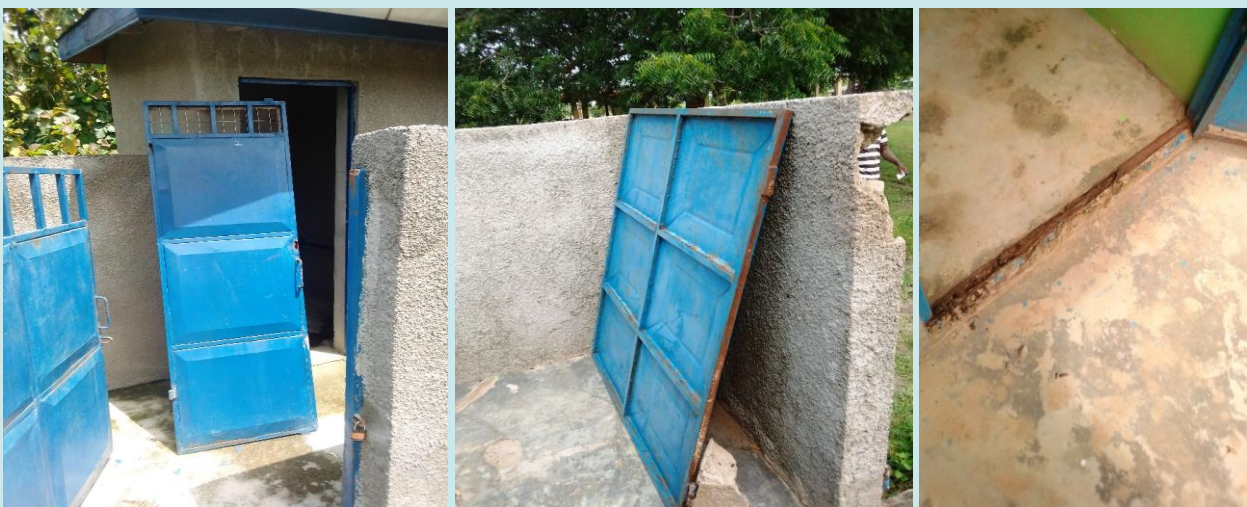
For most of the school facilities, there was evidence of rusting metal works. This was visible mostly on the gates to the facility and the gates to the cubicles. Due to the rusting, some hinges of these gates and doors have broken off and the gates fallen off. Protective cages for the water storage tanks also showed signs of rusting.

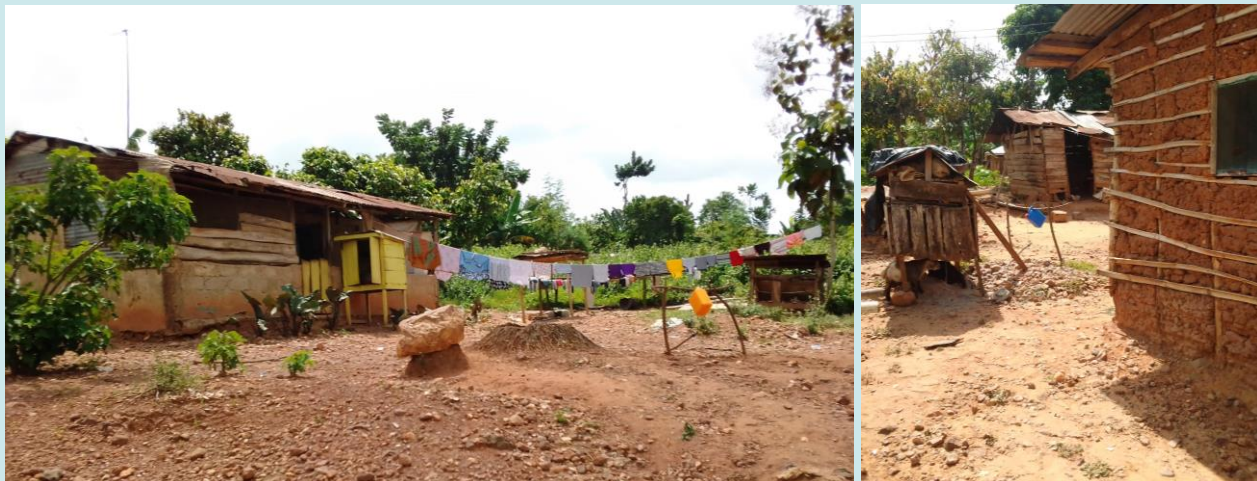
Box 10: WSMT members take up hygiene promotion activities:

In Minimade community (Ayensuano District), the community sanitation and hygiene promoter trained under the programme relocated in 2018. However, the other WSMT members have taken up his responsibilities. They monitor households' sanitation and hygiene practices regularly and provide follow-up support such as training where required and have even assisted residents to install tippy taps on their compounds. Collectively, they spend around three days a month on sanitation and hygiene related activities, with activities being conducted every Thursday (a rest day in the community). Additionally, they requested several resources (i.e., dustbins to collect solid waste, materials to produce tippy taps for community members still lacking a sanitation facility) to help them perform their roles.
